UNDERWATER FACILITIES INSPECTIONS AND ASSESSMENTS AT
NAVAL TRAINING CENTE. (U) BLAYLOCK-HILLIS AND
ASSOCIATES SAN DIEGO CA OCT 84

UNDERWATER FACILITIES INSPECTIONS & ASSESSMENTS

FPO-1-84(21)

OCTOBER 1984

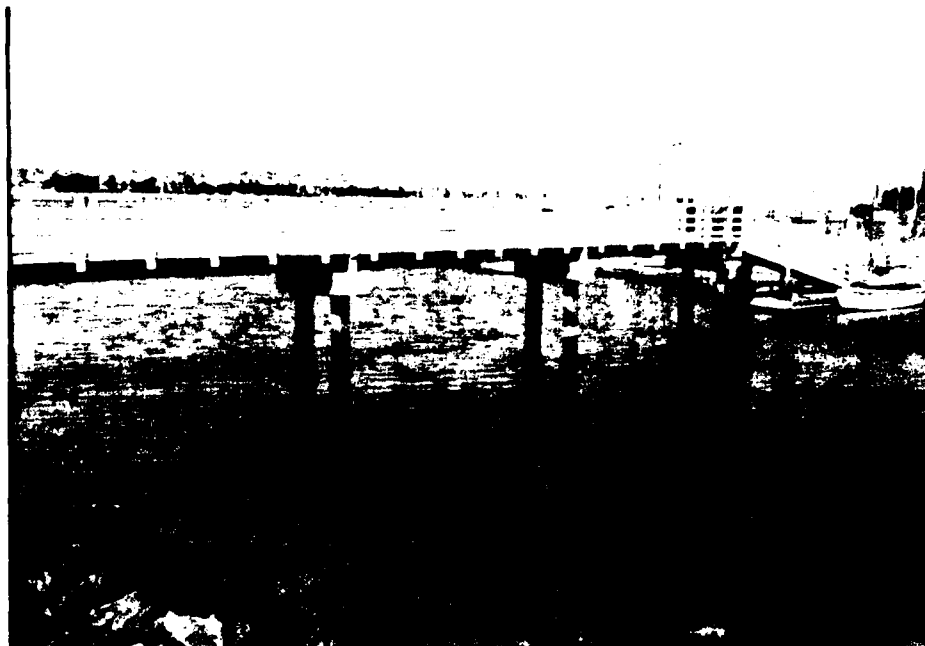
<u>PHOTO NO.</u>		<u>PAGE</u>
1.	Pier 548	4-5
2.	Pier 548, Pile 9-F. Picture is of surface of concrete pile after picking with pointed hammer as described in Section 3.2. The resulting spall is at right end of horizontal scale.	4-5

The supporting structure of Pier 548 is considered in good condition. It is recommended that it be inspected again in six years.

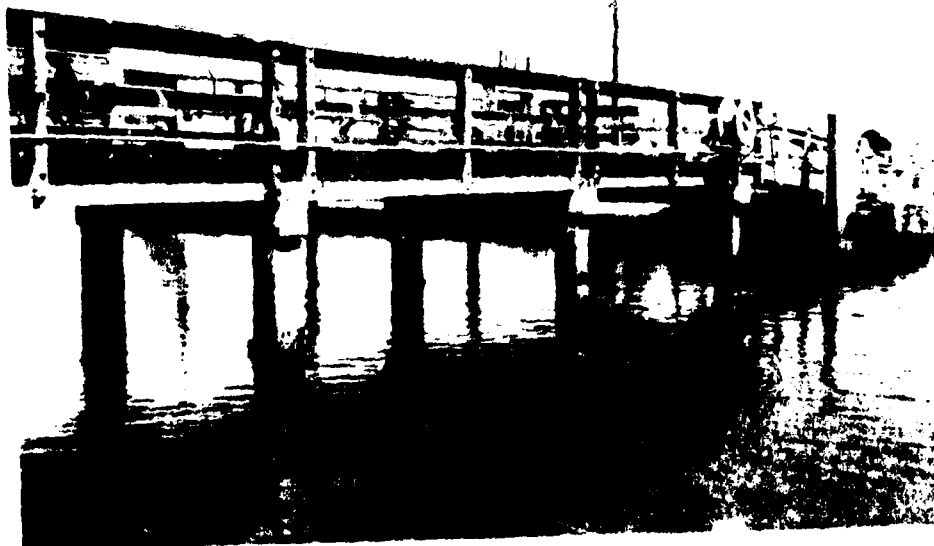
5.	Pier 445.	4-11
6.	Pier 445, Pile 1-B. The joint shown has the appearance of a joint between precast elements. The dry-pack material used to achieve level bearing has deteriorated.	4-11
